INSTITUTO DE PREVENÇÃO E INVESTIGAÇÃO  
DE ACIDENTES AERONÁUTICOS E MARÍTIMOS

**Investigation into Marine Accident  
Final Report**

**[N. 02/ACCID-M/IPIAAM/2020]**

Information about the original publication	
Title	M/V "DEIMOS" accident
Type of document	Safety Investigation Report
N. of document	02/ACCID - M/IPIAAM/2020
Date of publication

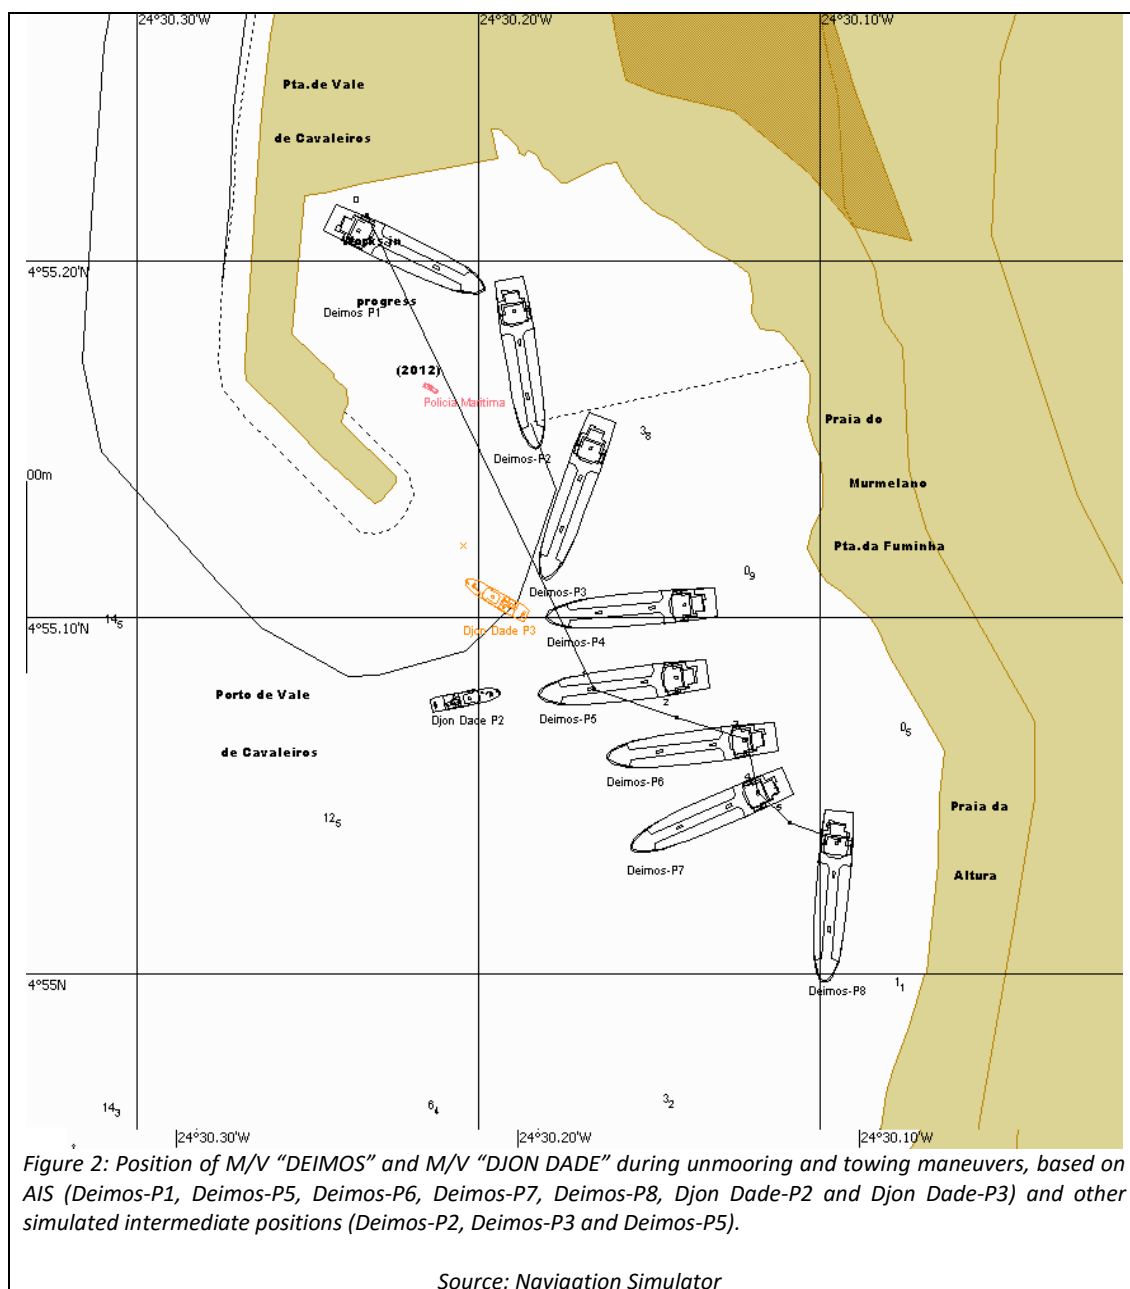
The vessel’s maneuver proceeded normally and she was moving ahead at a very slow speed towards the exit of the port area when around 7:35 am, the main engine began to gradually reduce rotation (DEIMOS-P1, Fig. 2), which caused its shutdown at 7:38 am

(DEIMOS-P2, Fig. 2) when the vessel was almost leaving the port area and with the tip of the breakwater on the starboard side.

At 07:40 am, the starboard anchor was dropped (DEIMOS-P3, Fig. 2), due to the little space and to the fact that the vessel continued drifting towards the shore, under the effect of the weather conditions.

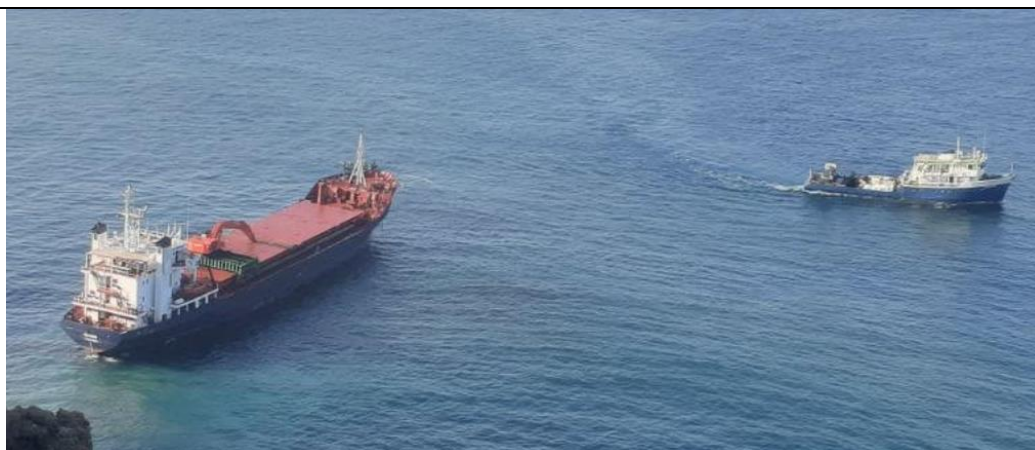
While M/V "DJON DADE" was being repositioned, M/V "DEIMOS" was dragged away to the hills and ran aground by around 8:17 am, after which the vessel touched the bottom of the sea for the first time, just as she was in a perpendicular position to the beach Praia da Altura. The vessel hit the bottom several times. Water started entering the engine room bilge, on the stern.

*Figure 3: M/V "DEIMOS" and M/V "DJON DADE" after the grounding.*

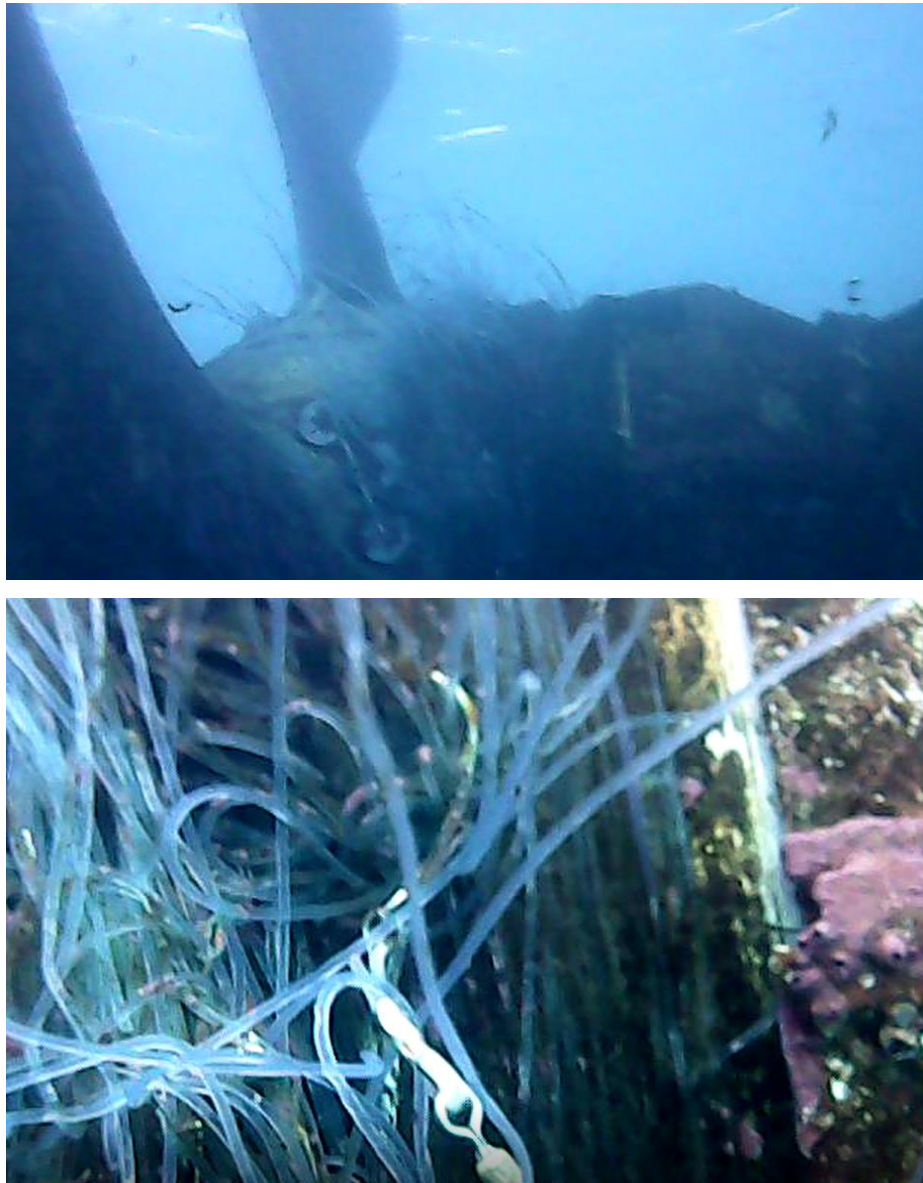
The divers found fishing gear wrapped in parts of the propeller and shaft, as shown in the following image:

Figure 7: Propeller and Shaft of M/V “DEIMOS” wrapped in fishing gear. Source: Videos - Dive Operation

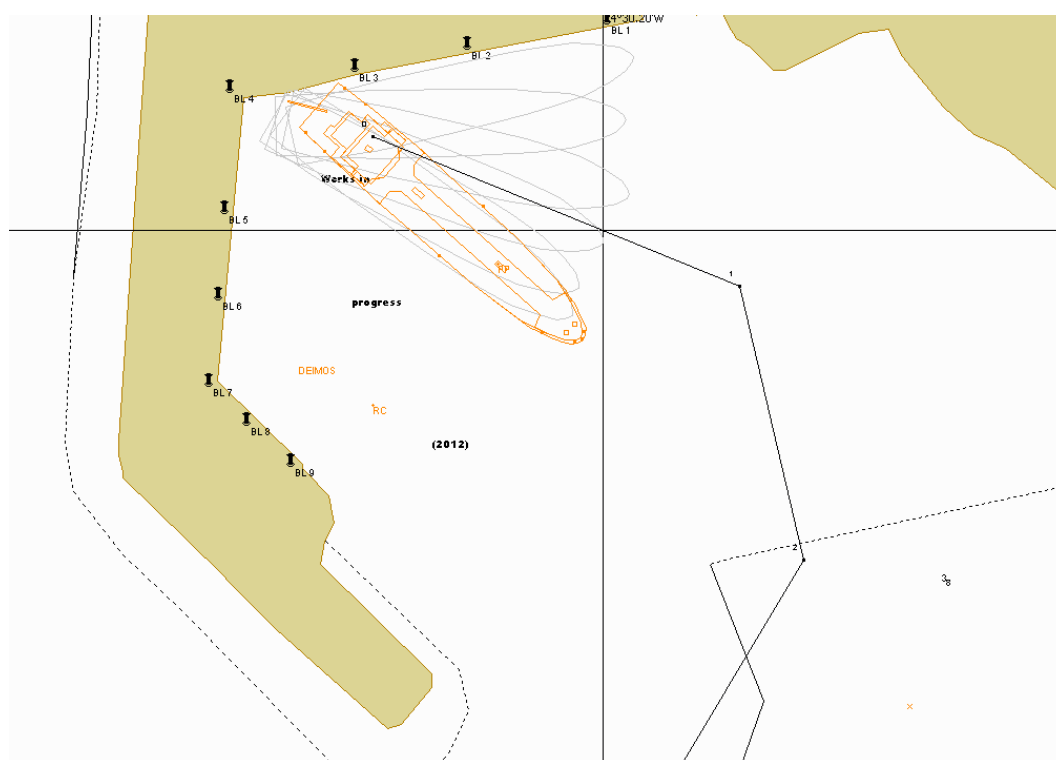
Figure 1: Vessel's position at 7:33 am (1319), using "Bow Thruster" and main engine. Source: Navigation Simulator.

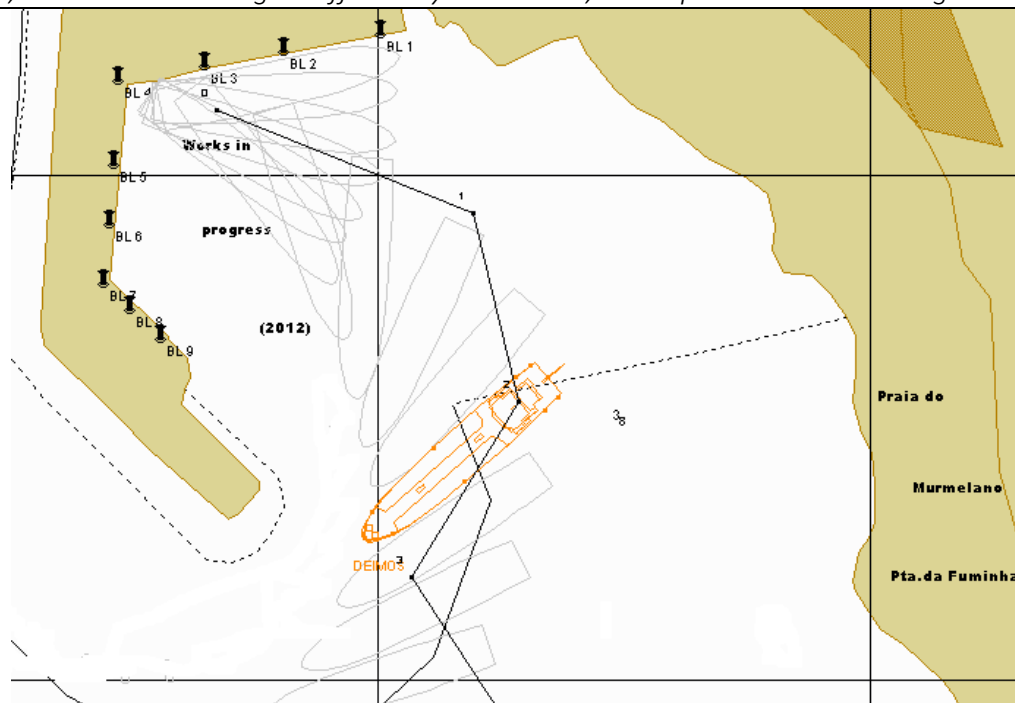
At 7:35 am, the vessel was already in the position indicated in Figure 11 when the main engine RPM reduced, and the vessel kept moving forward due to the inertia until 7:38 am, when the main engine effectively shut down, in the position shown in Figure 12.

Figure 2: Vessel position at 7:35 am after the main engine RPM was reduced. Source: Navigation Simulator.

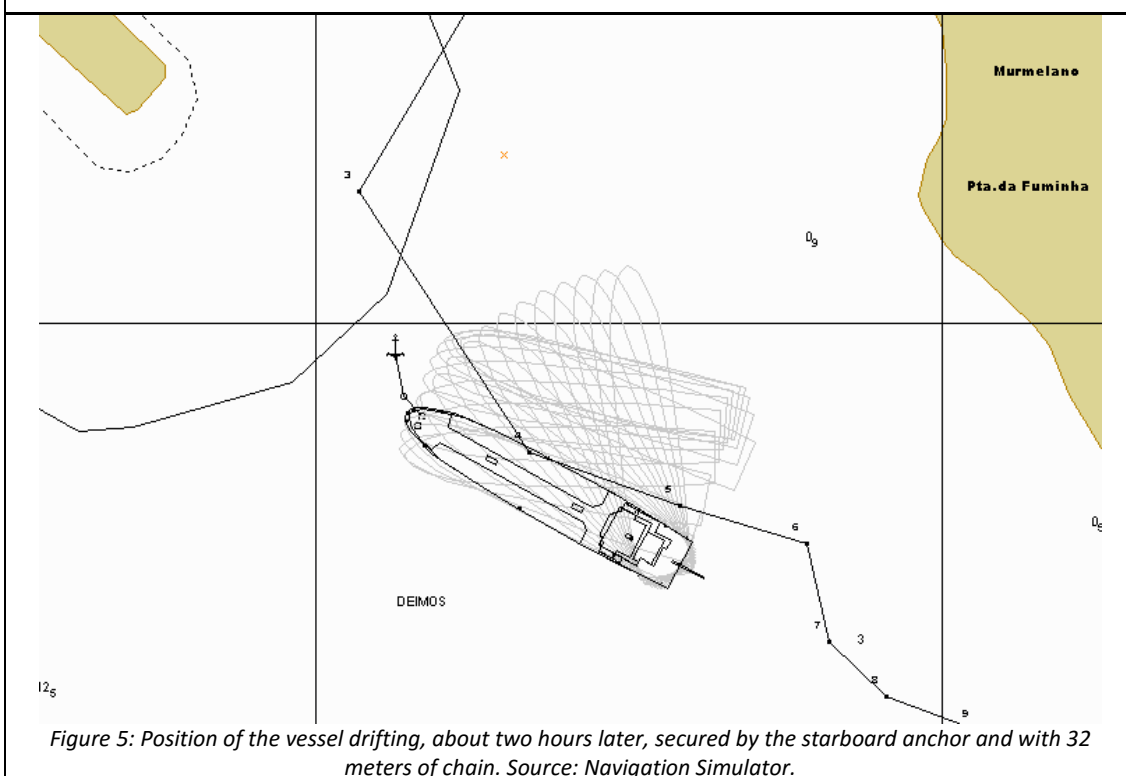
*However, as shown in Figure 15, if they had used a chain greater than 32 meters, the vessel would have run aground around 8:16 am. That is, since the distance from the anchor dropping position to the ground position equals 135 meters if the chain dropped was 40 meters long the distance would have been greater than 130 meters, as long as it is added to the length of the vessel (94.40 meters length overall) the 40 meters of chain.*

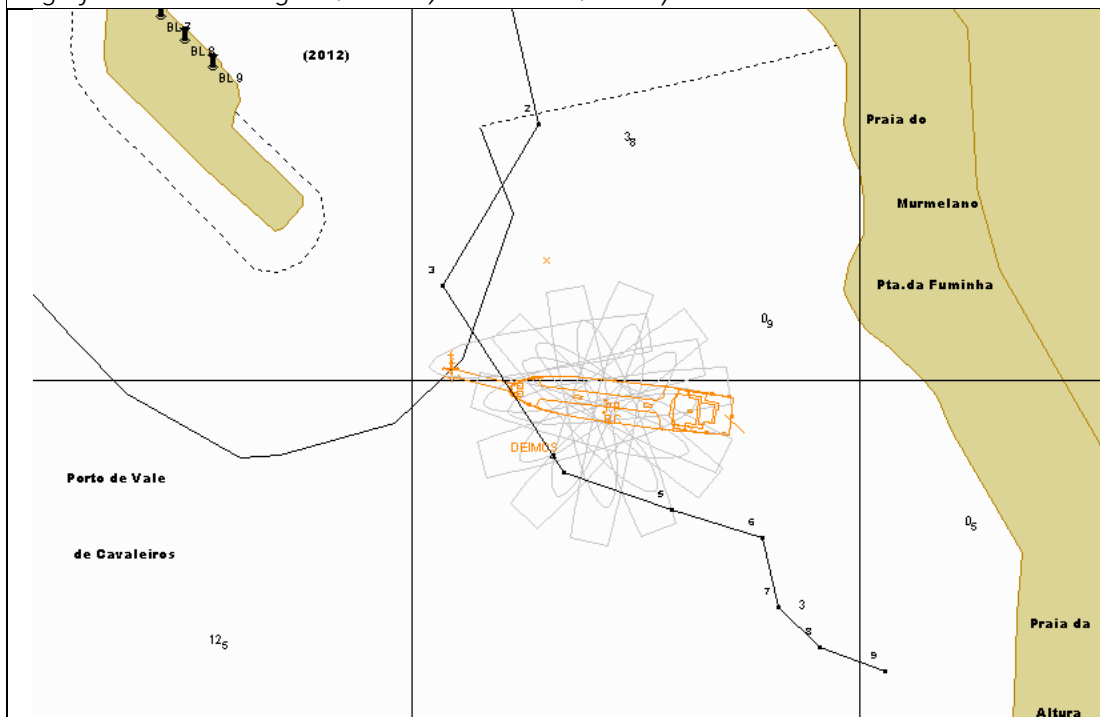
At 07:45 am, the vessel is in the position shown in Figure 17, secured by the two anchors and withstanding the weather conditions (Current → 110°/1.5 kn, Wind → 290/20 kn; Significant wave height → 1.5 m; Direction → 290°).

Figure 8: Vessel's position at 7:45 am, with the starboard and port anchors dropped. Source: Navigation Simulator.

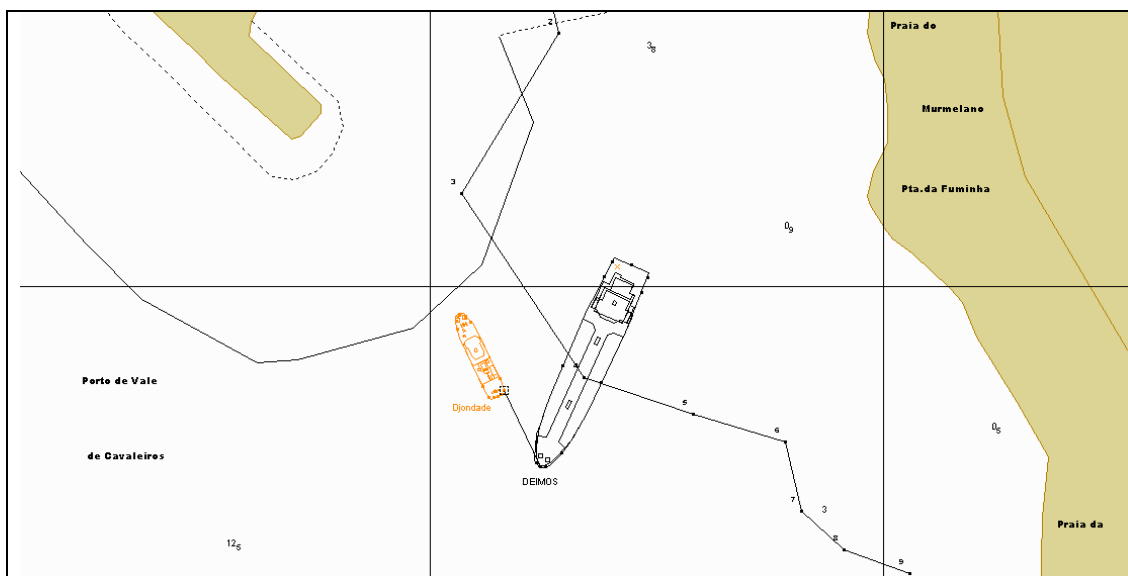
Figure 9: M/V "DJON DADE" towing M/V "DEIMOS" at 08:00 am: Source: Navigation Simulator.

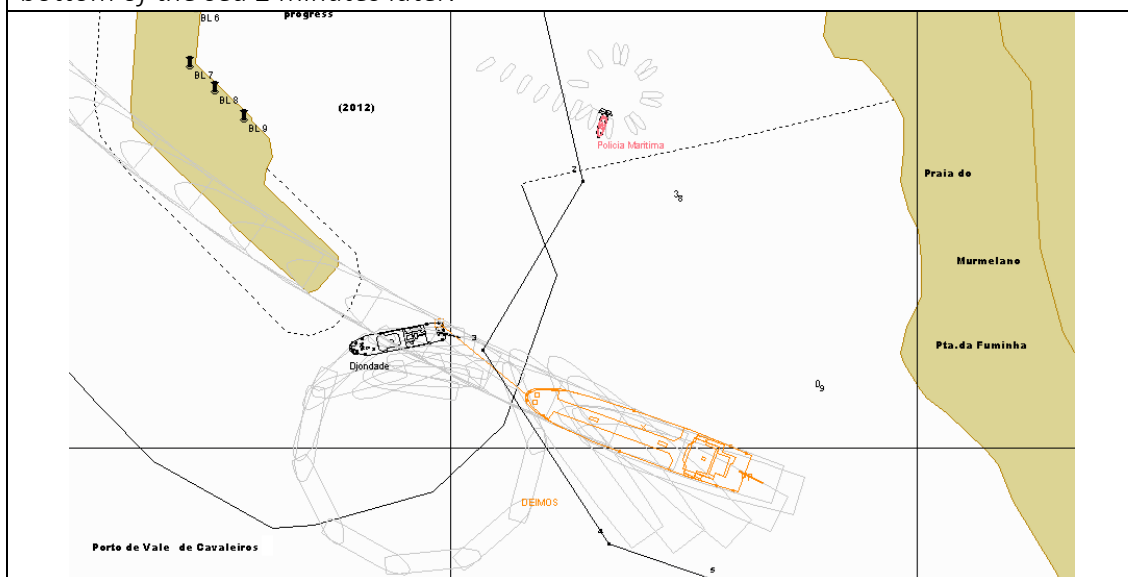
At 8:15 am, as shown in Figure 19, M/V "DJON DADE" tried to avoid the tip of the breakwater. At the risk of running aground, the master suspended the towing operation, to better position the vessel.

Drifting and without the assistance of M/V "DJON DADE", M/V "DEIMOS" touched the bottom of the sea 2 minutes later.

Figure 10: Position of M/V "DJON DADE" and M/V "DEIMOS" at 08:15 am Source: Navigation Simulator.

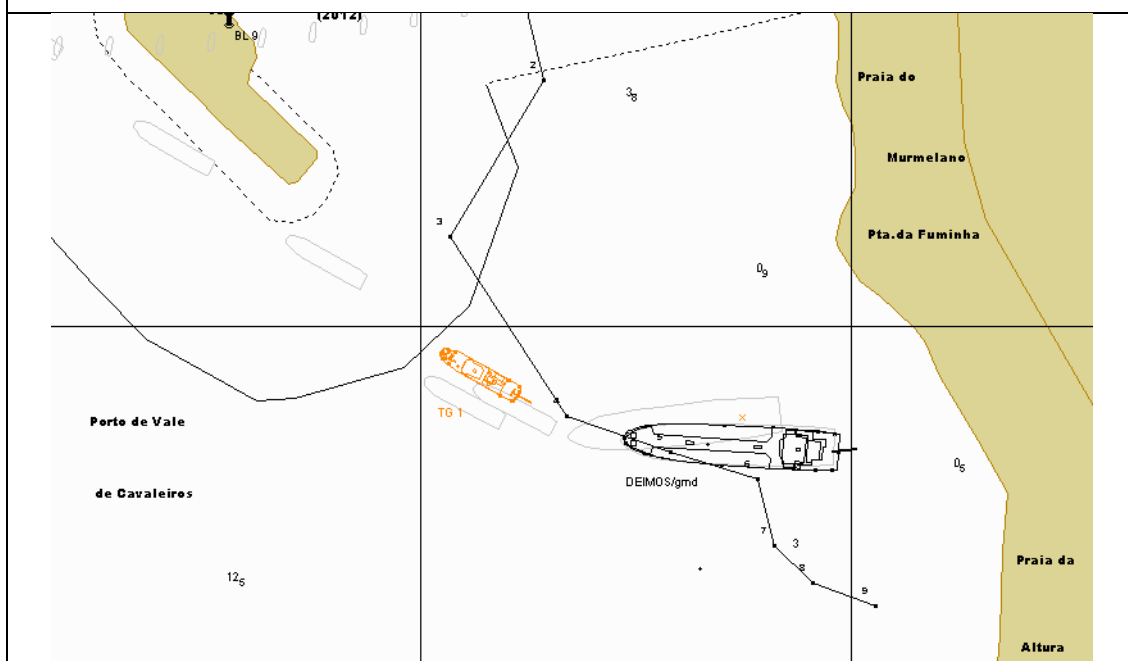
In the simulated conditions (Current  $\rightarrow 110^\circ/1.5$  kn, Wind  $\rightarrow 290/20$  kn; Significant wave height  $\rightarrow 1.5$  m; Direction  $\rightarrow 290^\circ$ ), it is verified that both vessels (M/V "DJON DADE" and M/V "DEIMOS") kept moving astern, approaching Praia da Altura and M/V "DEIMOS" would have run aground at 8:05 am, as shown in Figure 21.

**Conclusion:** Under the weather conditions indicated above, it would not be possible to avoid the grounding.

Figure 12: Position of M/V "DJON DADE" and M/V "DEIMOS" at 08:05 am: Source: Navigation Simulator.

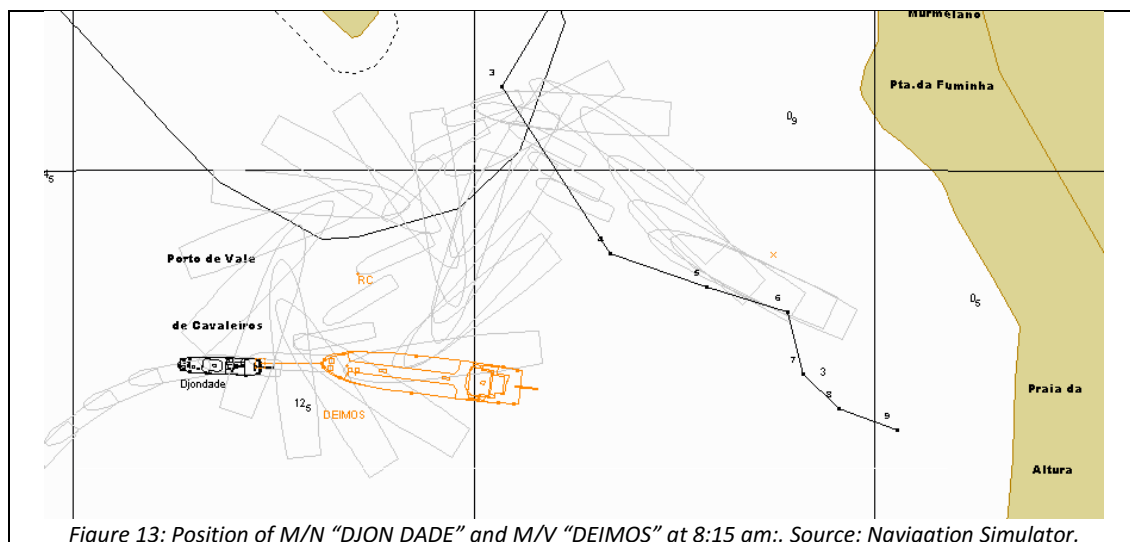
However, if the vessel had its speed altered to 1 knot, in the same conditions previously mentioned, namely, M/V "DEIMOS" using the bow thruster, it is assumed that the grounding could have been avoided. Figure 22 illustrates the position of both vessels, at 8:15 am.

Figure 13: Position of M/N “DJON DADE” and M/V “DEIMOS” at 8:15 am.: Source: Navigation Simulator.

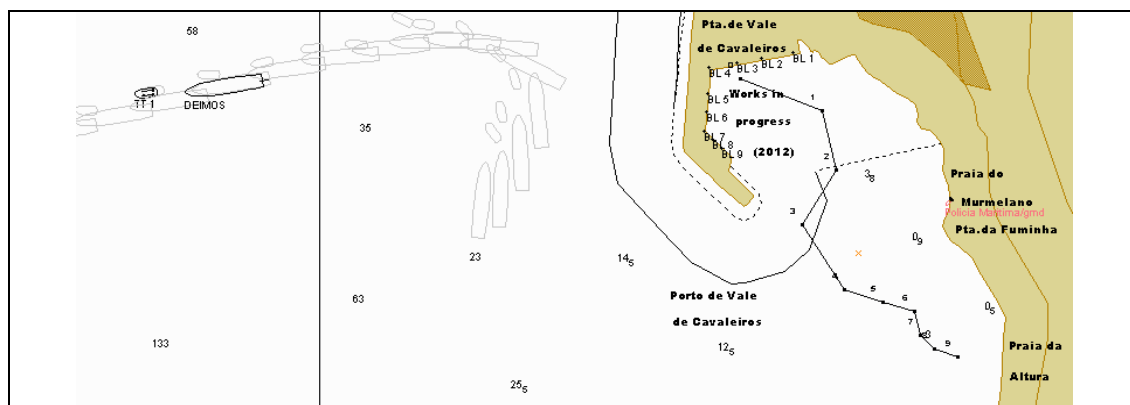
Figure 15: Tugboat “Praia Maria” towing M/V “DEIMOS” at 8:25 am: Source: Navigation Simulator

As shown in Figure 24, at 8:25 am, M/V “DEIMOS”, towed by the tugboat “PRAIA MARIA”, would have been able to anchor in a safe area, to await the main engine to get repaired.
