INSTITUTO DE PREVENÇÃO E INVESTIGAÇÃO  
DE ACIDENTES AERONÁUTICOS E MARÍTIMOS

**Investigation into Marine Accident  
Final Report**

**[N. 02/ACCID-M/IPIAAM/2020]**

Information about the original publication	
Title	M/V "DEIMOS" accident
Type of document	Safety Investigation Report
N. of document	02/ACCID - M/IPIAAM/2020
Date of publication

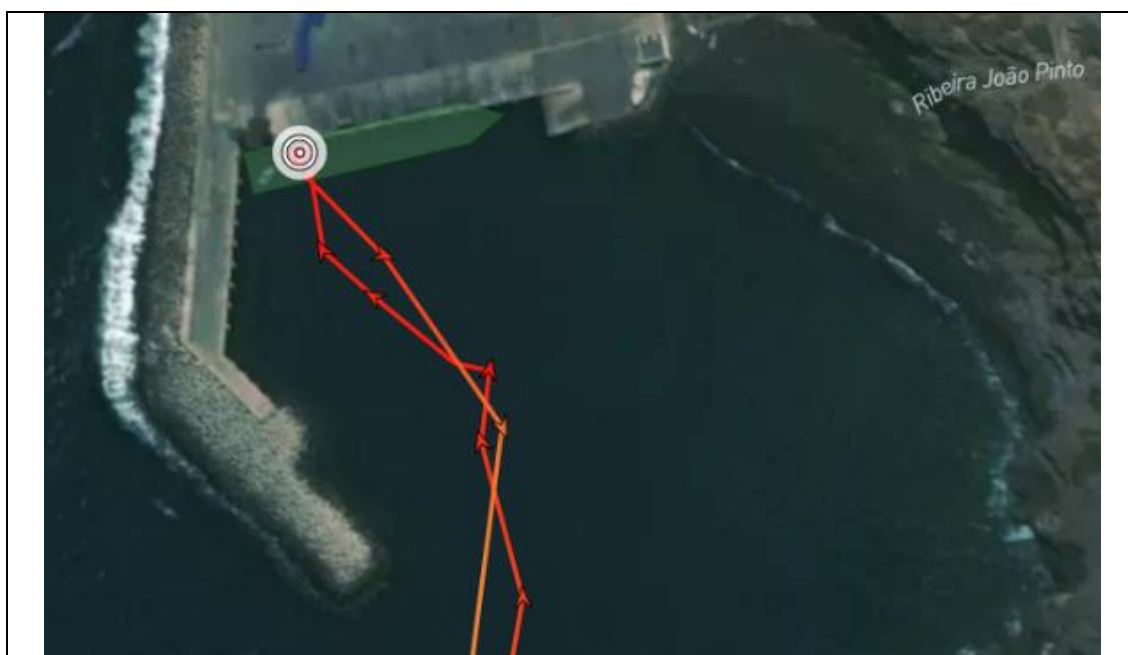
Figure 4: Arrival and departure from the Port of Vale de Cavaleiros, from 07 to 09 of September 2020. Source: Marine Traffic.

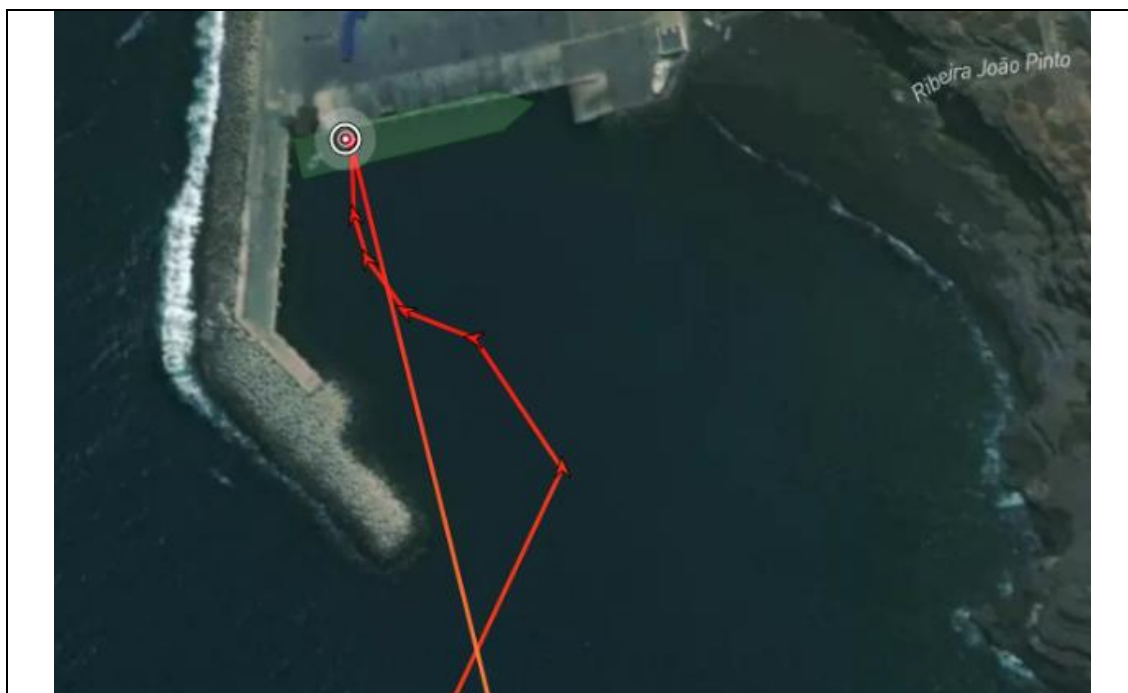
Figure 5: Arrival and departure from Port of Vale de Cavaleiros, from 07 to 09 of October 2020. Source: Marine Traffic.

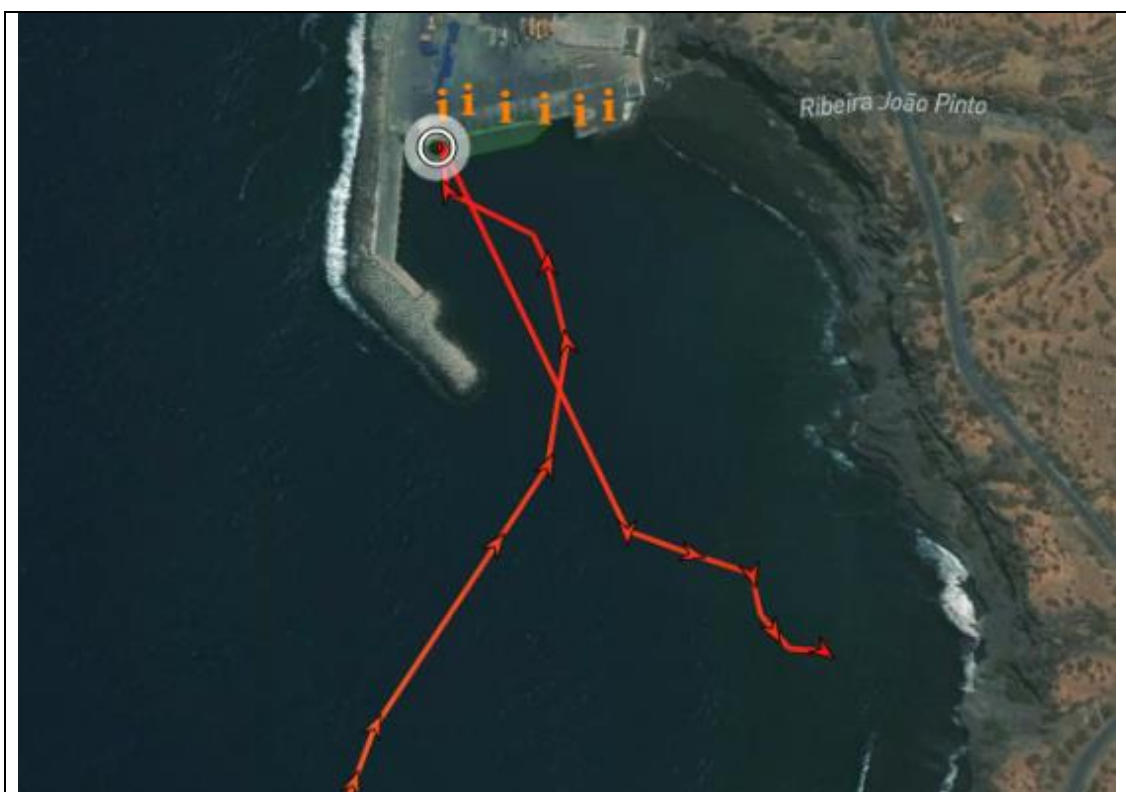
Figure 6: Arrival and departure from Port of Vale de Cavaleiros, from 11 to 13 of November 2020. Source: Marine Traffic.

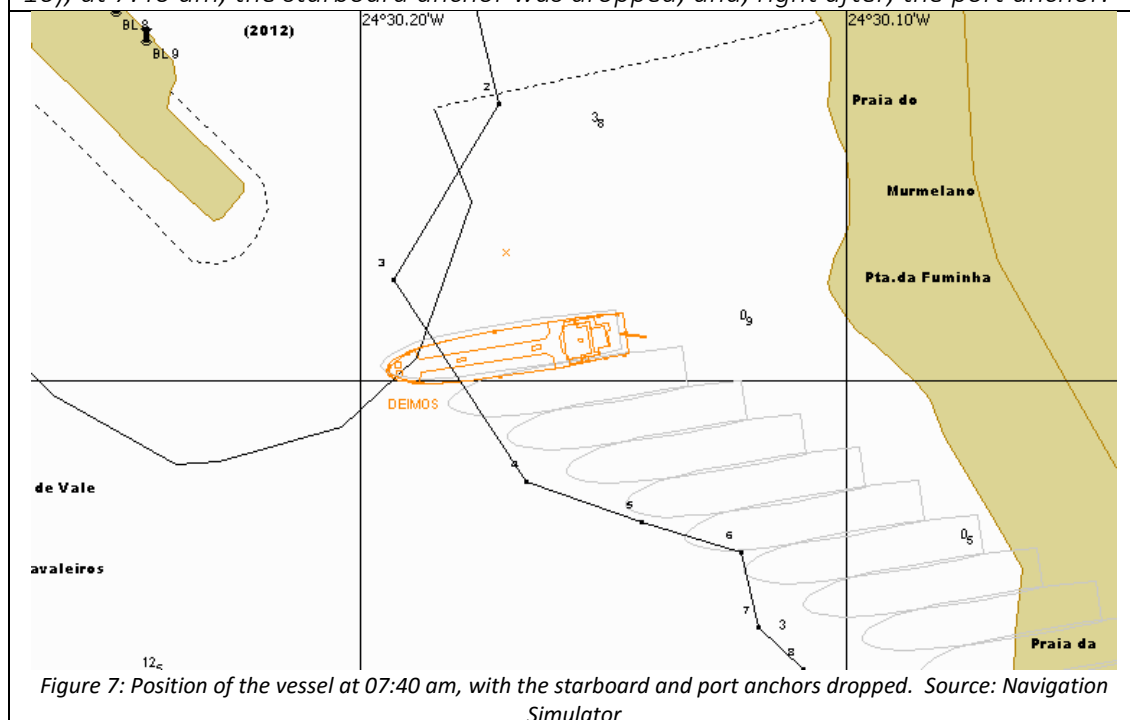
At 07:45 am, the vessel is in the position shown in Figure 17, secured by the two anchors and withstanding the weather conditions (Current → 110°/1.5 kn, Wind → 290/20 kn; Significant wave height → 1.5 m; Direction → 290°).

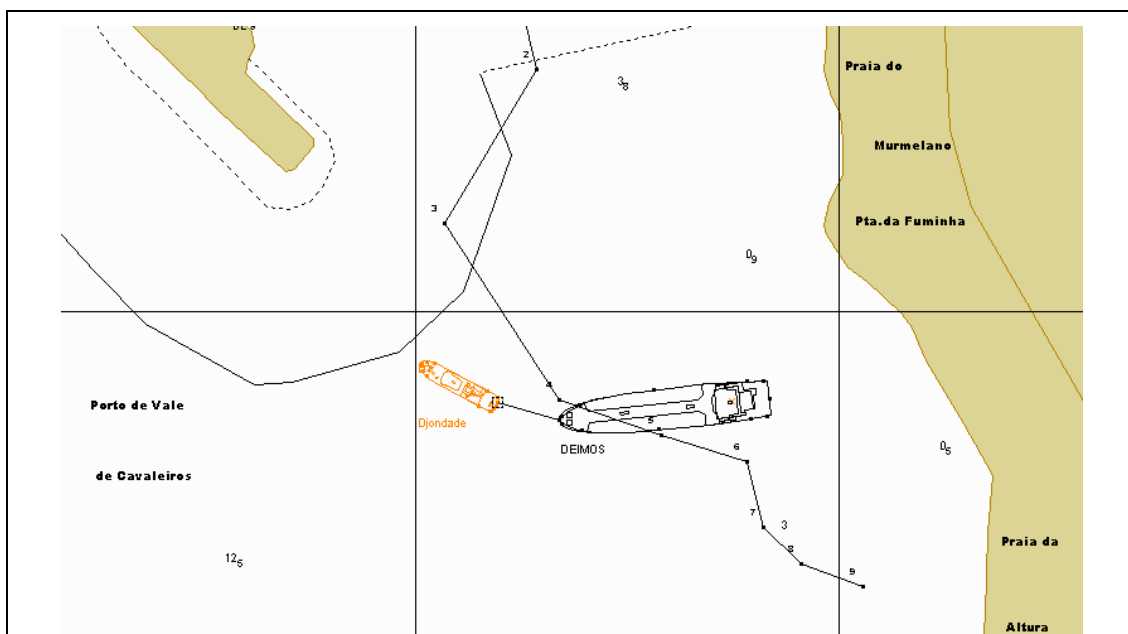
Figure 11: Position of M/V "DJON DADE" and M/V "DEIMOS" at 08:00 am: Source: Navigation Simulator.

In the simulated conditions (Current  $\rightarrow 110^\circ/1.5$  kn, Wind  $\rightarrow 290/20$  kn; Significant wave height  $\rightarrow 1.5$  m; Direction  $\rightarrow 290^\circ$ ), it is verified that both vessels (M/V "DJON DADE" and M/V "DEIMOS") kept moving astern, approaching Praia da Altura and M/V "DEIMOS" would have run aground at 8:05 am, as shown in Figure 21.

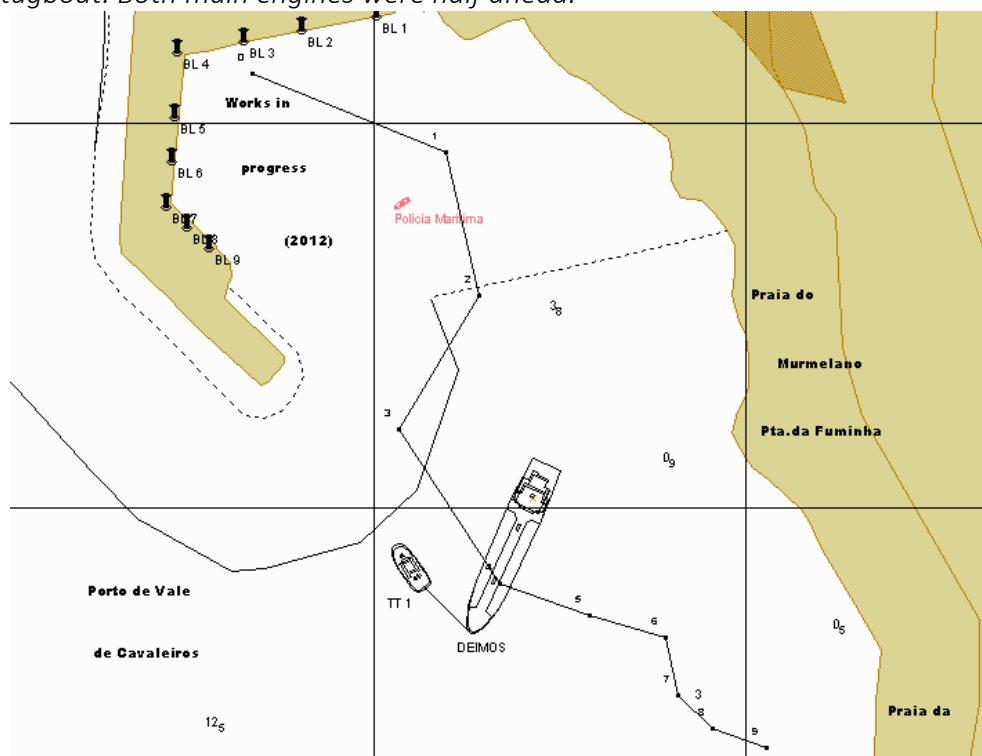
In the simulation, the towing started at 8:00 am (Figure 23), the nylon cable is connected at the bow of M/V “DEIMOS” and the 30 meters long cable is at the stern of the tugboat. Both main engines were half ahead.

Figure 14: Tugboat “Praia Maria” towing M/V “DEIMOS” at 8:00 am: Source: Navigation Simulator
