INSTITUTO DE PREVENÇÃO E INVESTIGAÇÃO  
DE ACIDENTES AERONÁUTICOS E MARÍTIMOS

## **Final Report**

**On the Incident of September 14<sup>th</sup>,  
With the B757-200 registered G-OOBA  
Aircraft**

**Operated by TUI Airways Limited  
Flight TOM579, Boa Vista (BVC) – London  
(LGW)**

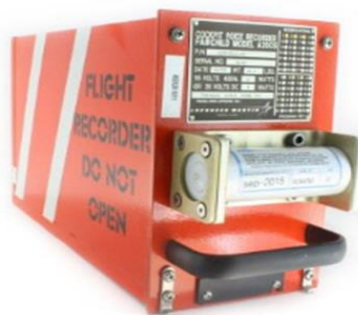
- ✓ Manufacturer: Honeywell;
- ✓ Model: SSCVR;
- ✓ Part number (P/N): 980-6022-001;
- ✓ Serial number (S/N): CVR120-06564;

Figure 6 - Cockpit Voice Recorder (CVR)
